TS-PIC-9902269S
March 1999

AERIAL PHOTOGRAPHIC ANALYSIS
LCP CHEMICALS, INC., SITE

Linden, New Jersey

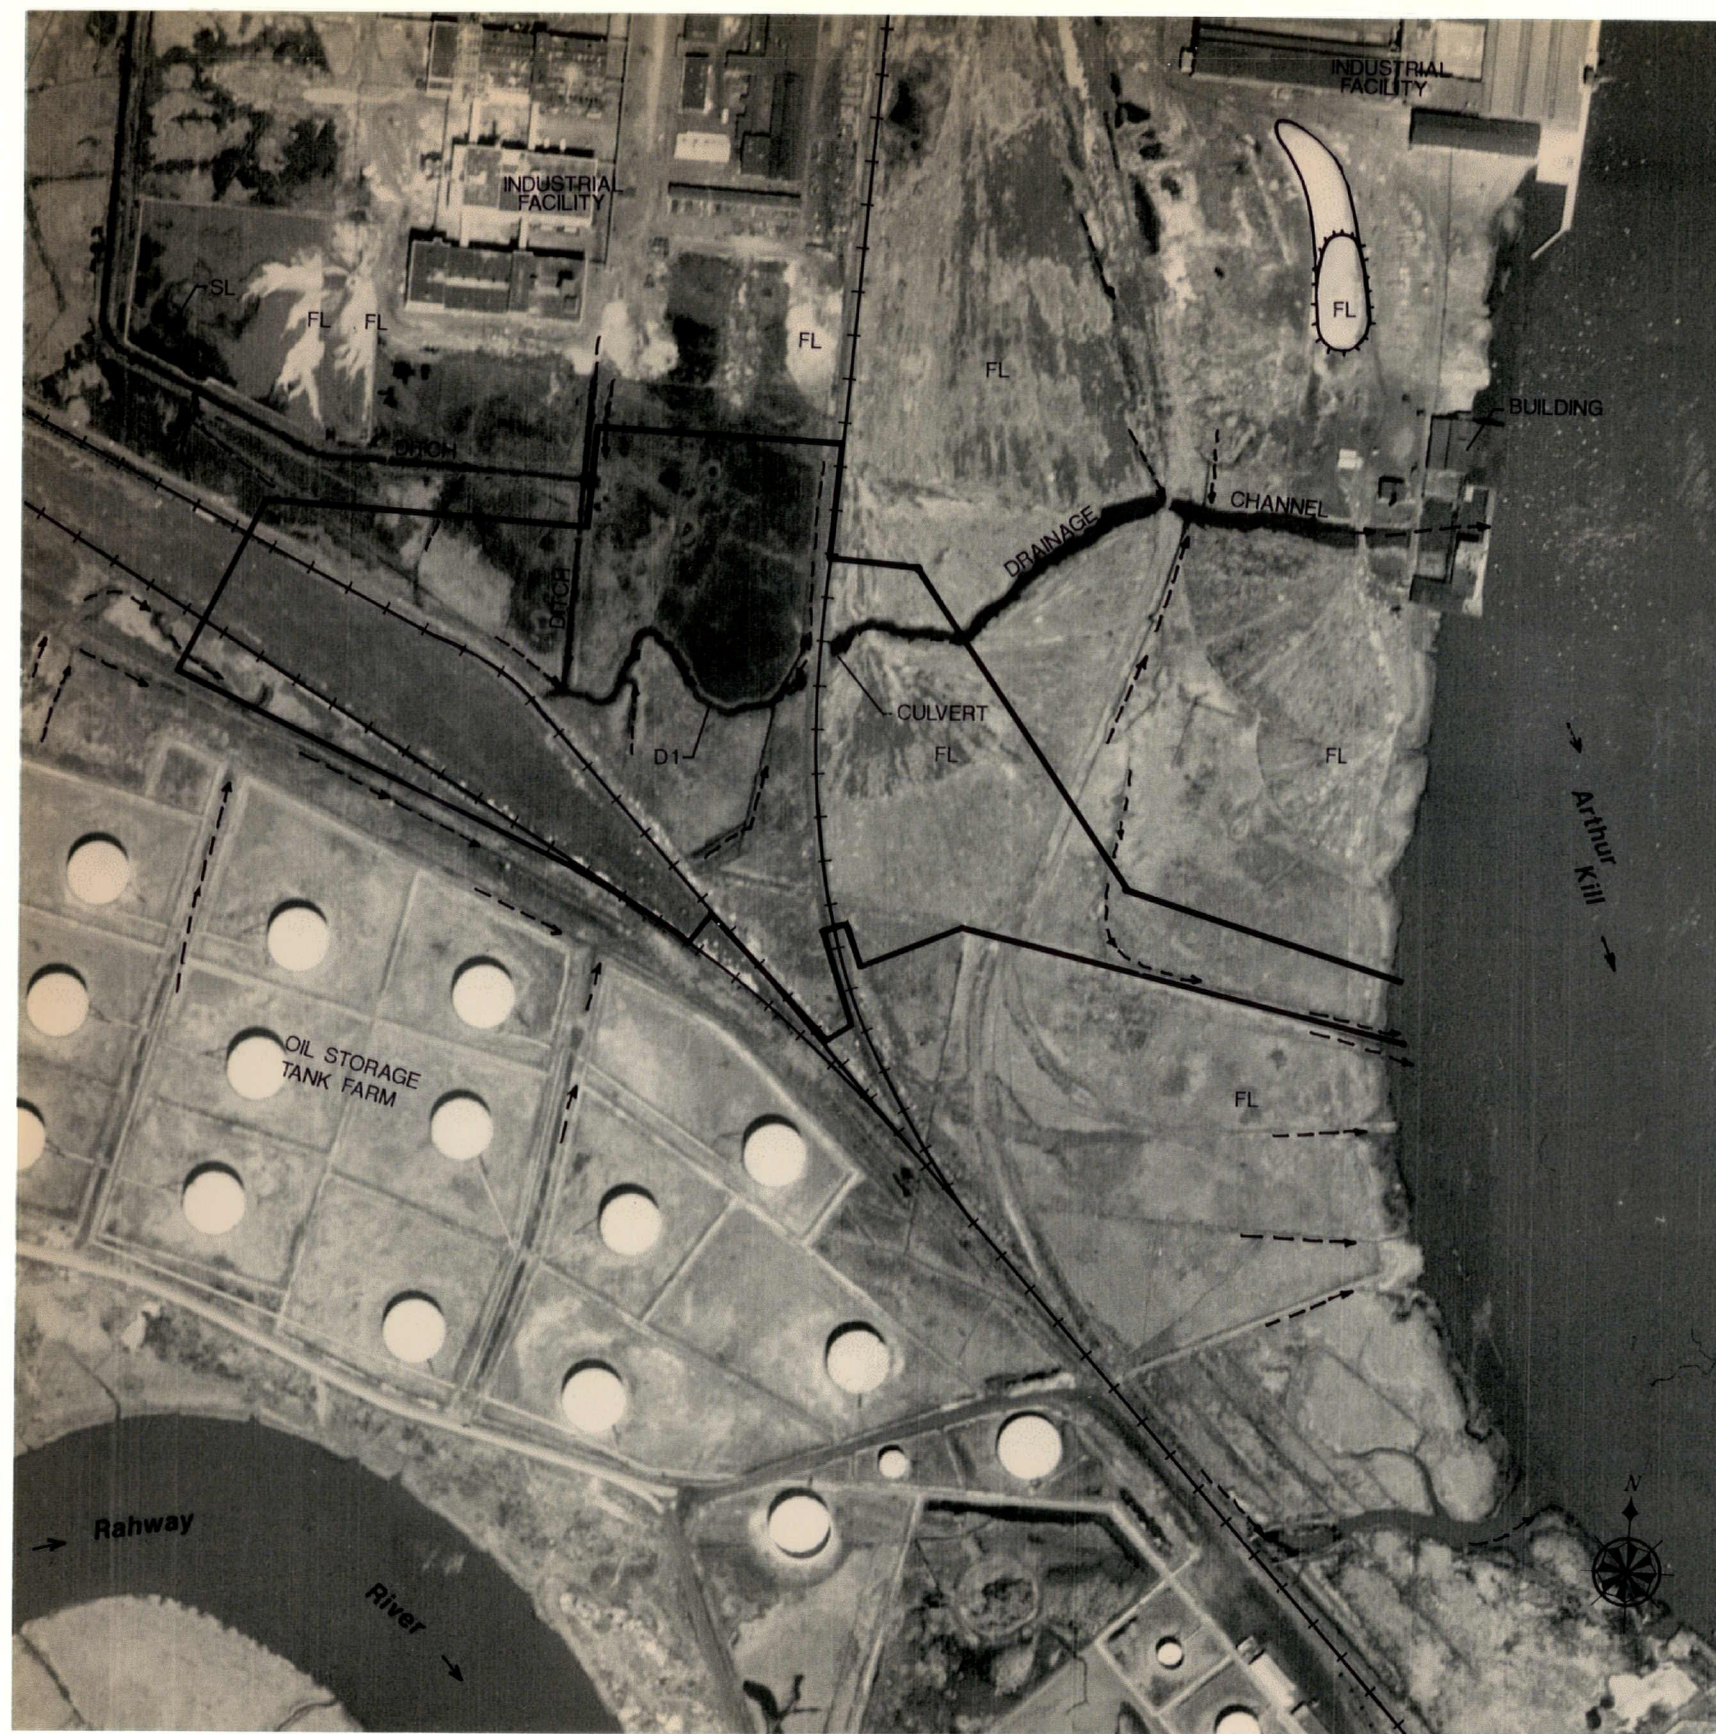
Figure 3. LCP Chemicals, Inc., site, April 28, 1940. Approximate scale 1:4,300.

APRIL 28, 1940 (FIGURE 3)

Photographic analysis reveals the site in 1940 is undeveloped and the LCP Chemicals, Inc., site has not been established. The site is situated within an industrial area of Tremley Point. The site is adjacent to the Arthur Kill. There is an industrial facility to the north and an oil storage tank farm to the south of the site. The site boundary annotated on the photograph is based on the approximate size of the LCP Chemicals, Inc., site as observed on a 1995 photograph.

Regional drainage flows east into the Arthur Kill. Channelized drainage ditches have been dug next to and across portions of the site. A culvert under a railroad track allows runoff in the drainage ditch (D1) to leave the site and flow east into the Arthur Kill. Portions of the west bank of the Arthur Kill are in the process of being filled.

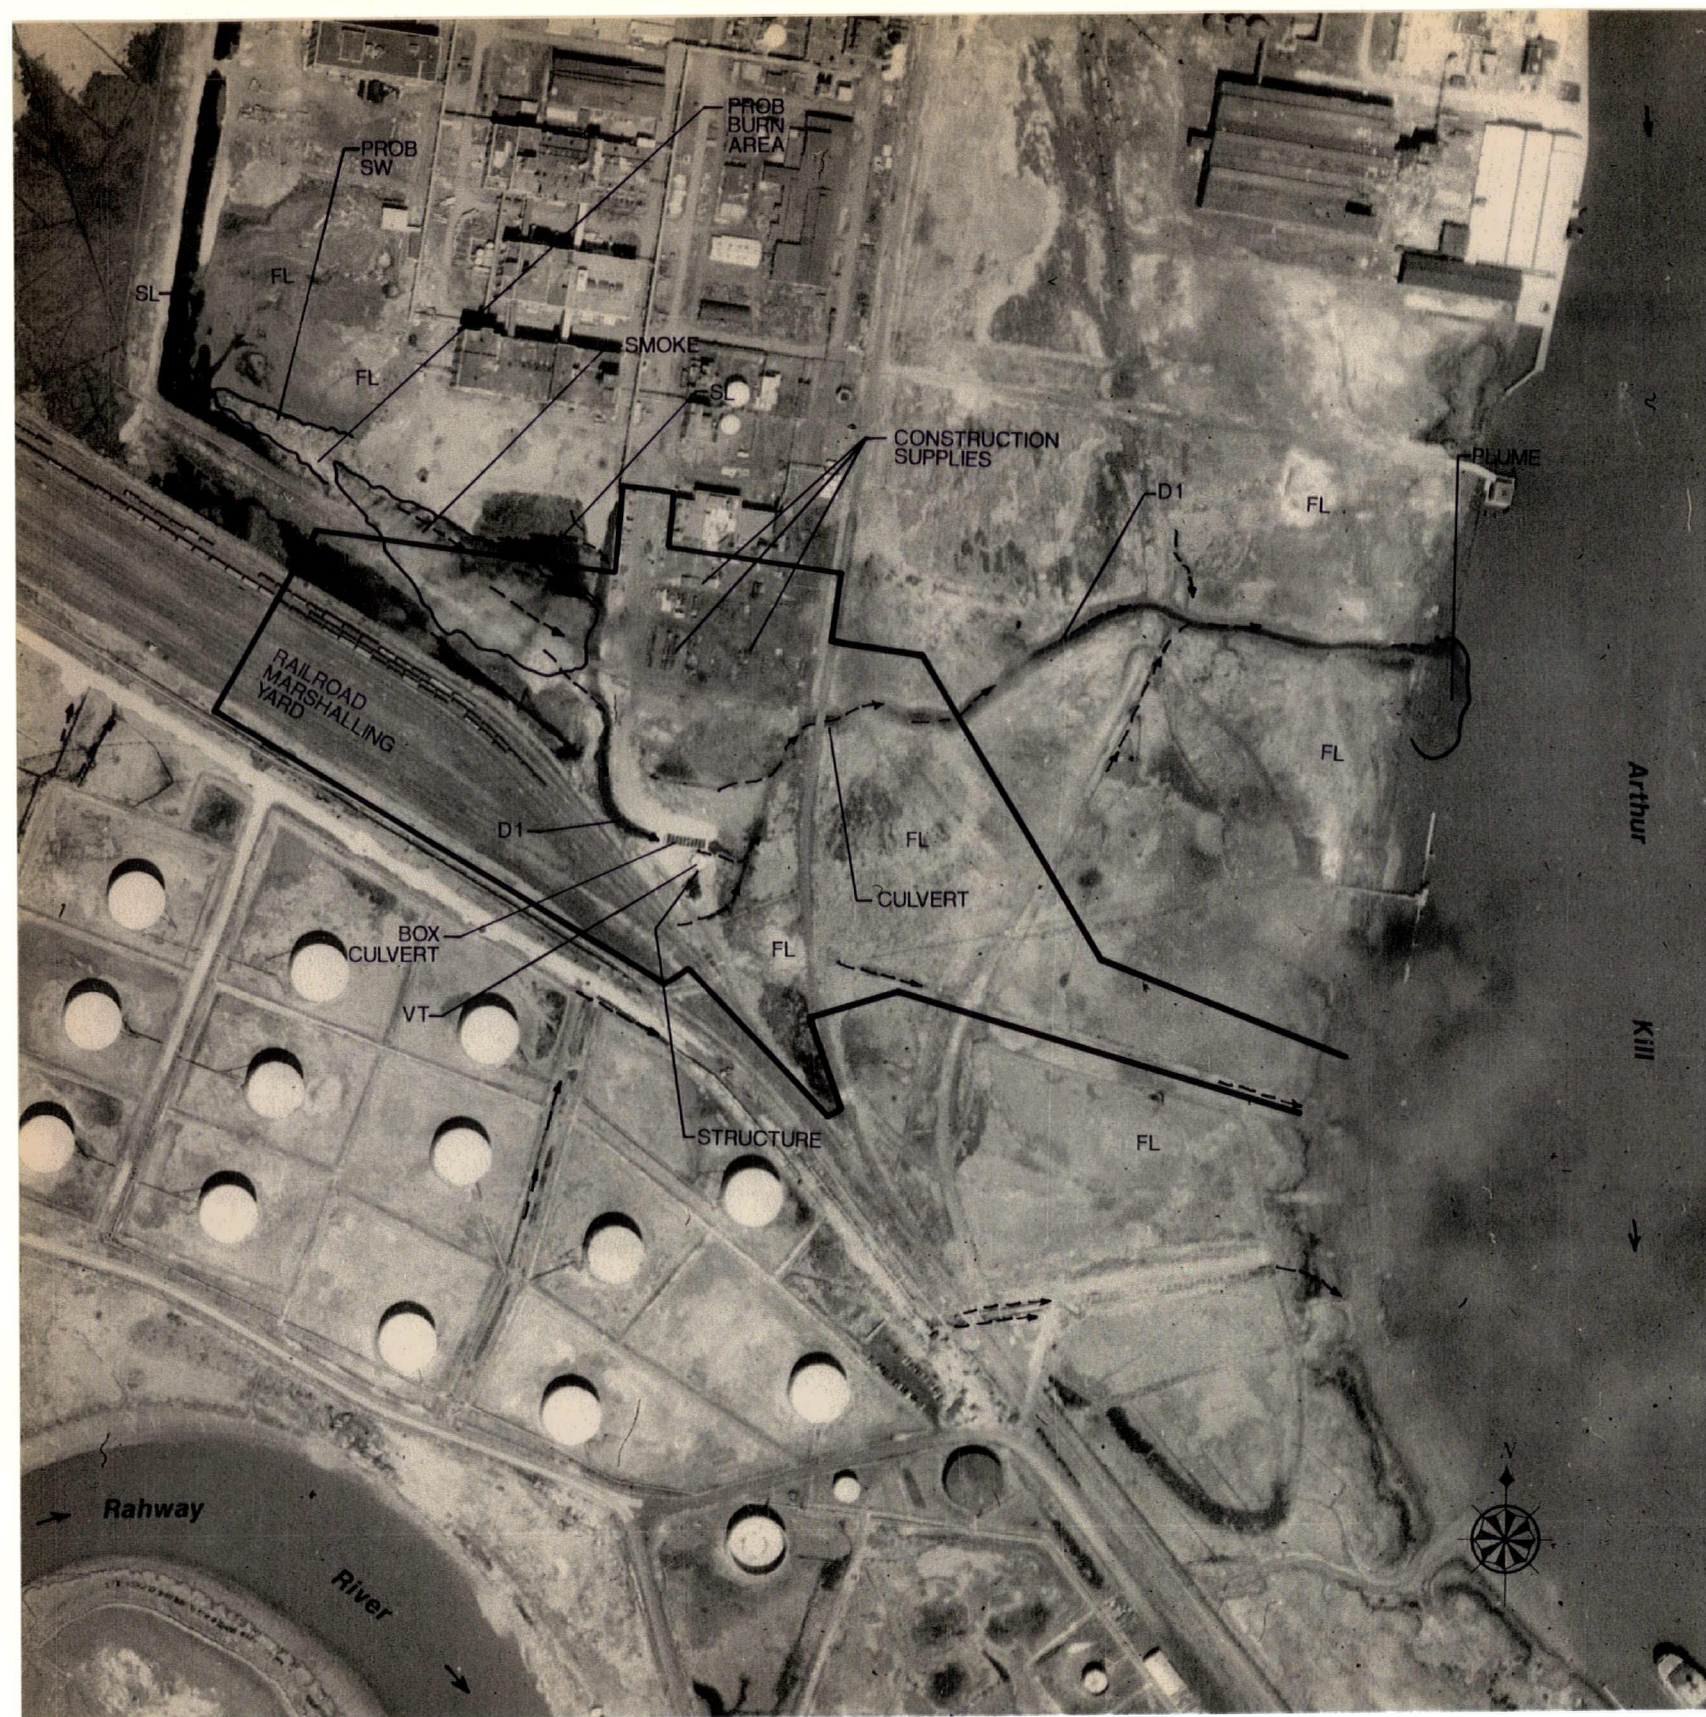
Figure 4. LCP Chemicals, Inc., site, April 20, 1951. Approximate scale 1:4,600.

APRIL 20, 1951 (FIGURE 4)

There are no structures, buildings, or tanks on the site. Probable construction supplies and building materials are observed on the north side of drainage ditch D1. Since 1940 a railroad marshalling yard has been completed on the western side of the site. A vertical tank (VT) and a tall structure have been constructed on the south side of ditch D1.

A probable burn area and fill area (FL) are outside and northwest of the site. A cloud of smoke hangs over this probable burn area and the northwest portion of the site. Drainage from this northwest area flows across the site via ditches that connect to ditch D1.

Drainage continues to leave the site but the course of ditch D1 has been modified by a box culvert, still under construction, in the central portion of the site. The ditch D1 also appears to receive runoff from the industrial plant and fill areas northeast of the site. A dark-toned plume is visible at the mouth of ditch D1 as its contents flow into the Arthur Kill.

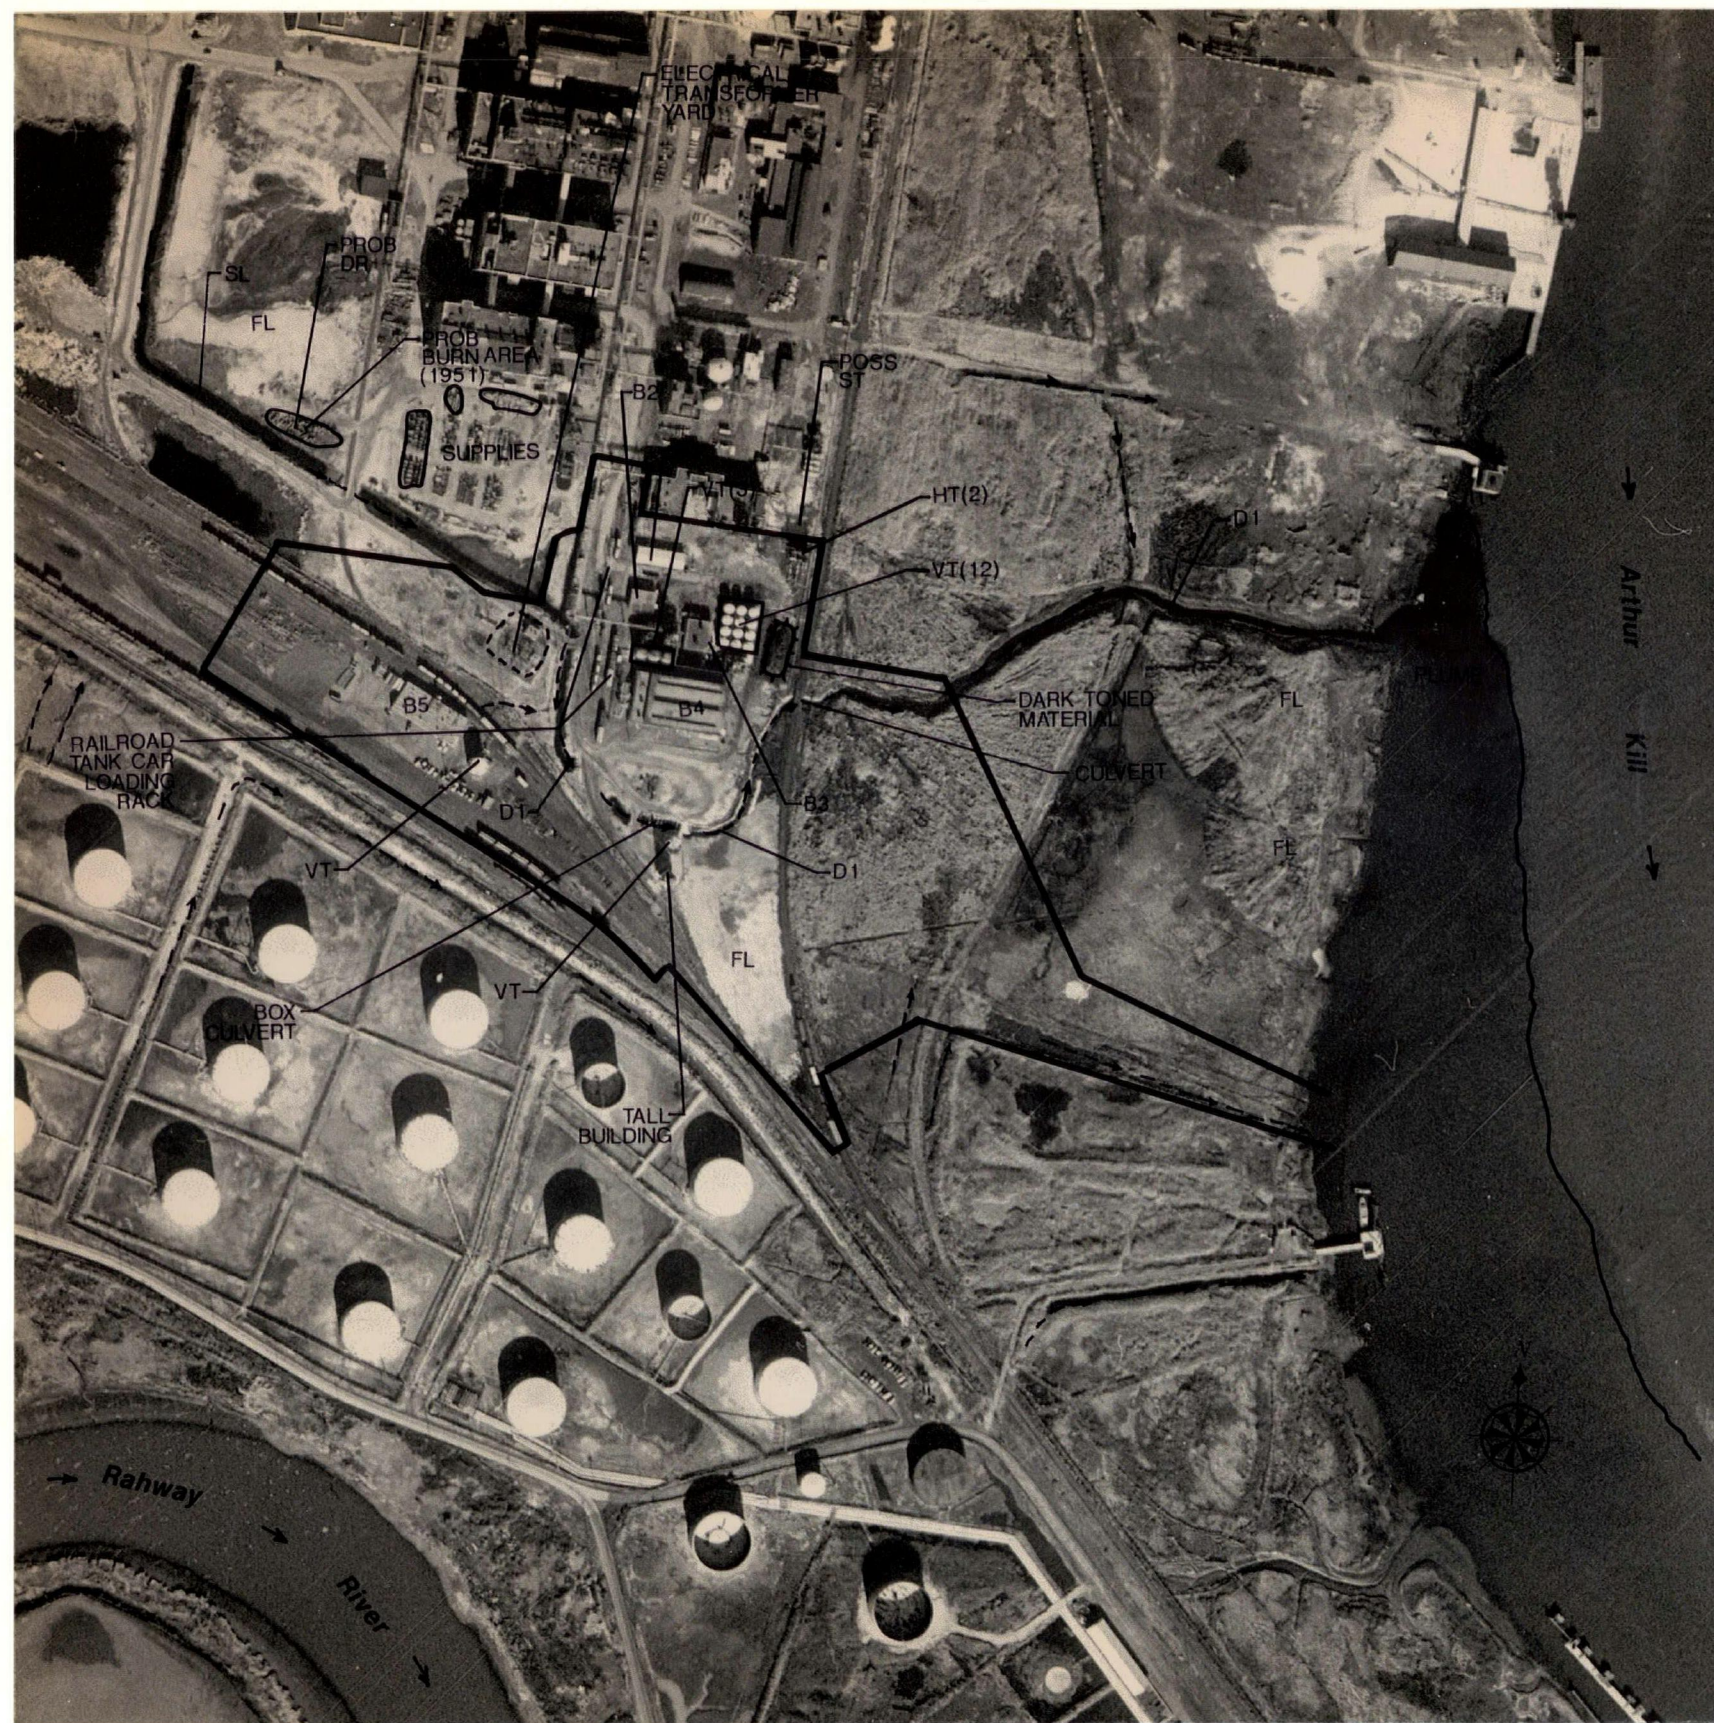
Figure 5. LCP Chemicals, Inc., site, November 20, 1958. Approximate scale 1:4,500.

NOVEMBER 20, 1958 (FIGURE 5)

An industrial plant is under construction in the north portion of the site. The facility contains four buildings (B1 through B4), two railroad tank car loading racks, a group of 12 vertical storage tanks, a separate group of three vertical storage tanks, and two horizontal storage tanks (HT). An electrical transformer yard has been constructed on the western portion of the site. A large mound of dark-toned material is in the northeast portion of the site. The ground adjacent to the northeast horizontal storage tanks has a dark tone suggesting possible stain (ST) from past spillage or leakage. The presence of pipeage, storage or processing tanks, a railroad tank car loading rack, an electrical transformer yard for power, and location of the site adjacent to industrial facilities suggests the site is a probable chemical production plant.

Since 1951 a portion of the railroad marshalling yard on the southwest portion of the site has been removed. A vertical storage tank and a large building (B5) have been constructed at this location. Improved photo resolution allows the structure adjacent to the vertical storage tank in the south-central portion of the site to be identified as a tall building.

No smoke is observed at the former probable burn area noted in 1951 outside and northwest of the site. A large group of probable 55-gallon drums (DR) is now visible in this area. The area north of these probable drums is being leveled with fill; however, standing liquid is still in this area.

Drainage ditch D1 continues to flow across the site and transports runoff from the former burn area. A dark-toned plume is visible at the mouth of ditch D1 as it discharges into the Arthur Kill. The areal extent of the plume has greatly expanded to the north, east, and south since the 1951 photograph.

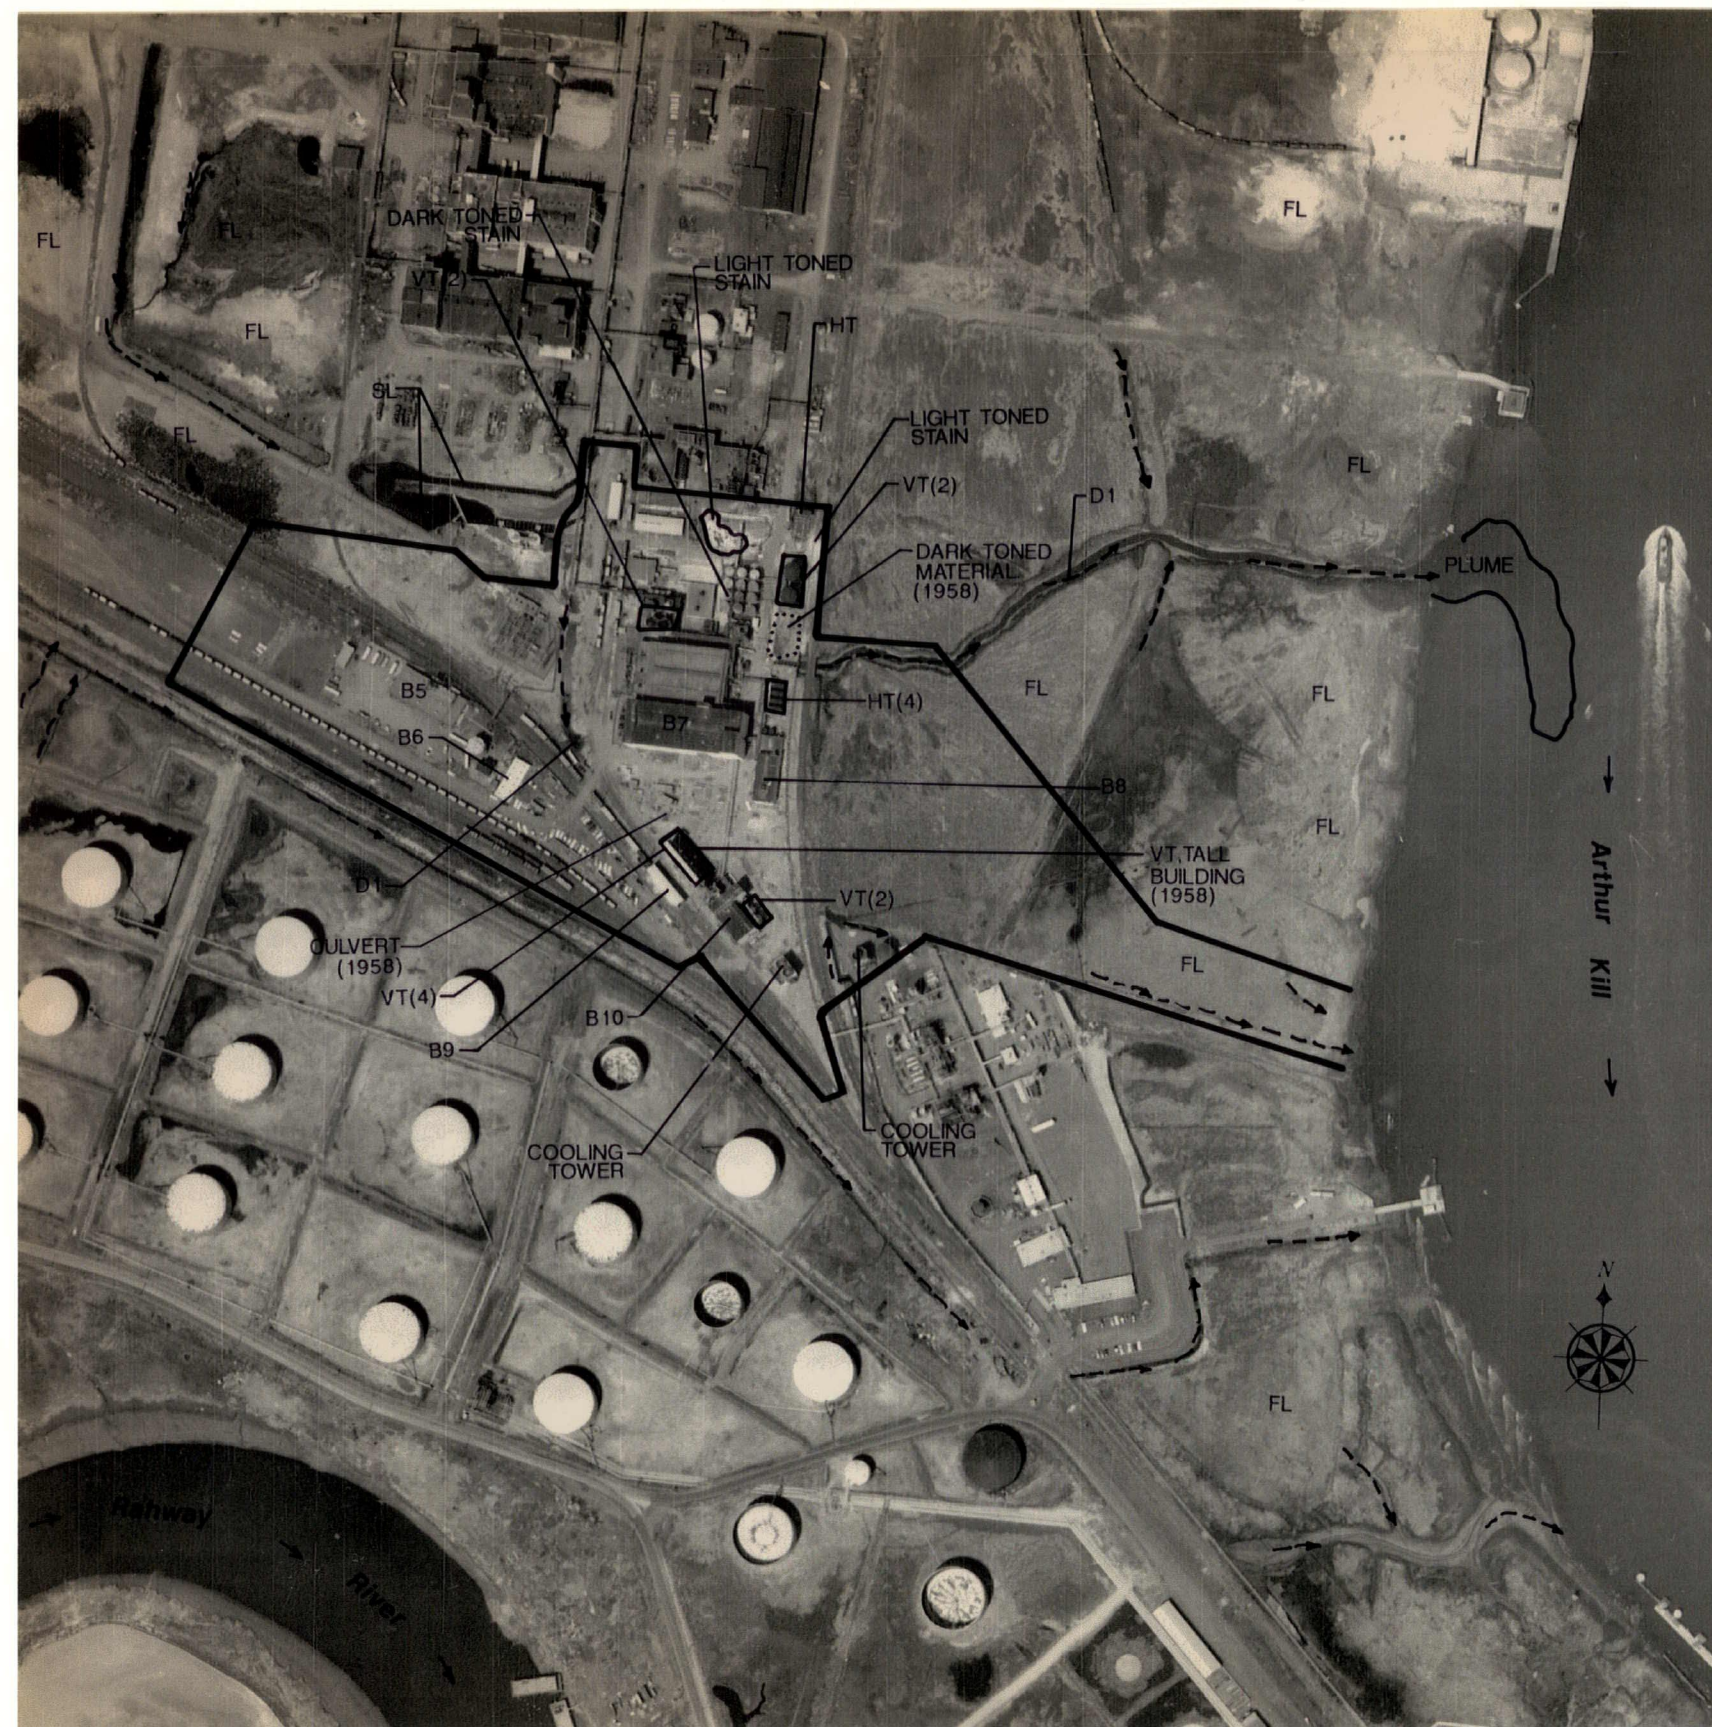
Figure 6. LCP Chemicals, Inc., site, May 4, 1963. Approximate scale 1:4,400.

MAY 4, 1963 (FIGURE 6)

Five new buildings (B6 through B10) have been constructed and three vertical and four horizontal storage or processing tanks have been added. The large mound of dark-toned material visible in 1958 is absent. The southern portion of the site which has been filled, graded, and leveled now contains two new buildings (B9 and B10) and six vertical tanks. The vertical tank and tall building observed at this location in 1958, are absent. Two cooling towers have been built near this southern location of the plant.

A portion of drainage ditch D1 is no longer visible and the box culvert under construction in 1958 has evidently been completed and covered. As a result of construction activity within the site boundary a portion of drainage ditch D1 has probably been piped underground. However, the eastern portion of drainage ditch D1 is above ground, visible, and continues to transport runoff. A faint, dark-toned plume is discernible at the mouth of this ditch as it empties into the Arthur Kill. The areal extent of this plume is smaller than the plume noted on the 1958 photograph.

Light- and dark-toned ground stains are observed in the northern portion of the chemical plant, possibly suggesting past spillage or leakage. Potential contaminants associated with this leakage or spillage could be transported into drainage ditch D1 via rainwater runoff, and reach the Arthur Kill.

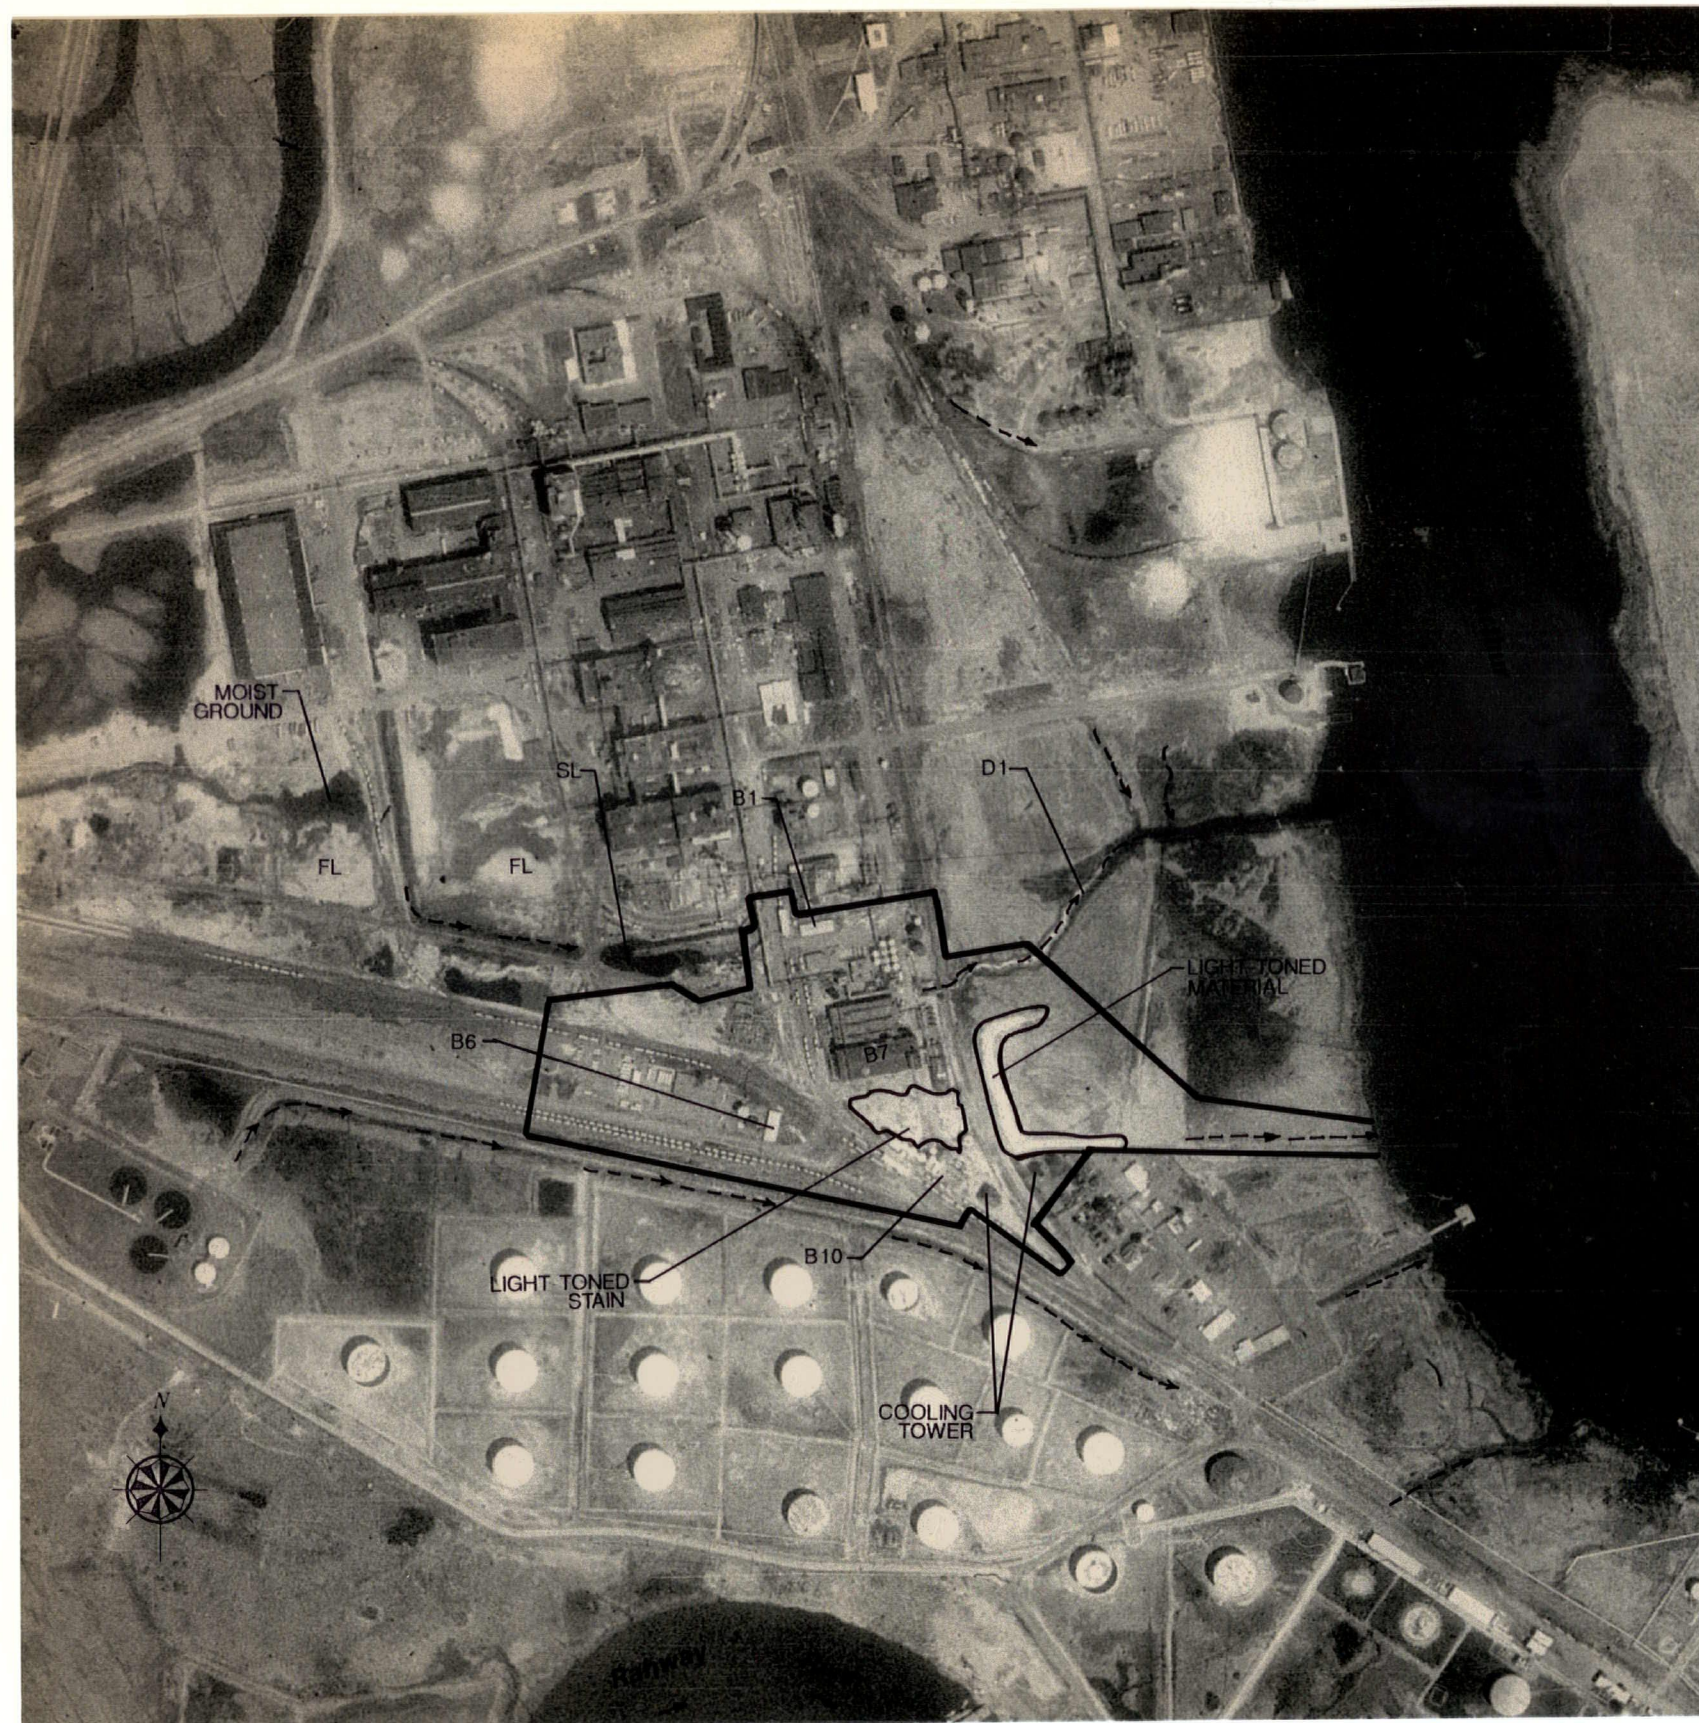
Figure 7. LCP Chemicals, Inc., site, April 30, 1967. Approximate scale 1:6,400.

APRIL 30, 1967 (FIGURE 7)

Poor photo resolution precludes a detailed analysis of conditions at the chemical plant in 1967. Analysis of the photograph shows the chemical plant continues to operate. No significant new construction is discerned. Several buildings (B1, B6, B7, and B10) have been annotated as reference locations.

A widespread light-toned ground stain is discerned in the southern portion of the site. A large probable deposit of light-toned material is discerned on the east side of the site. The curved shape of this probable deposit appears more like a berm rather than a stockpile.

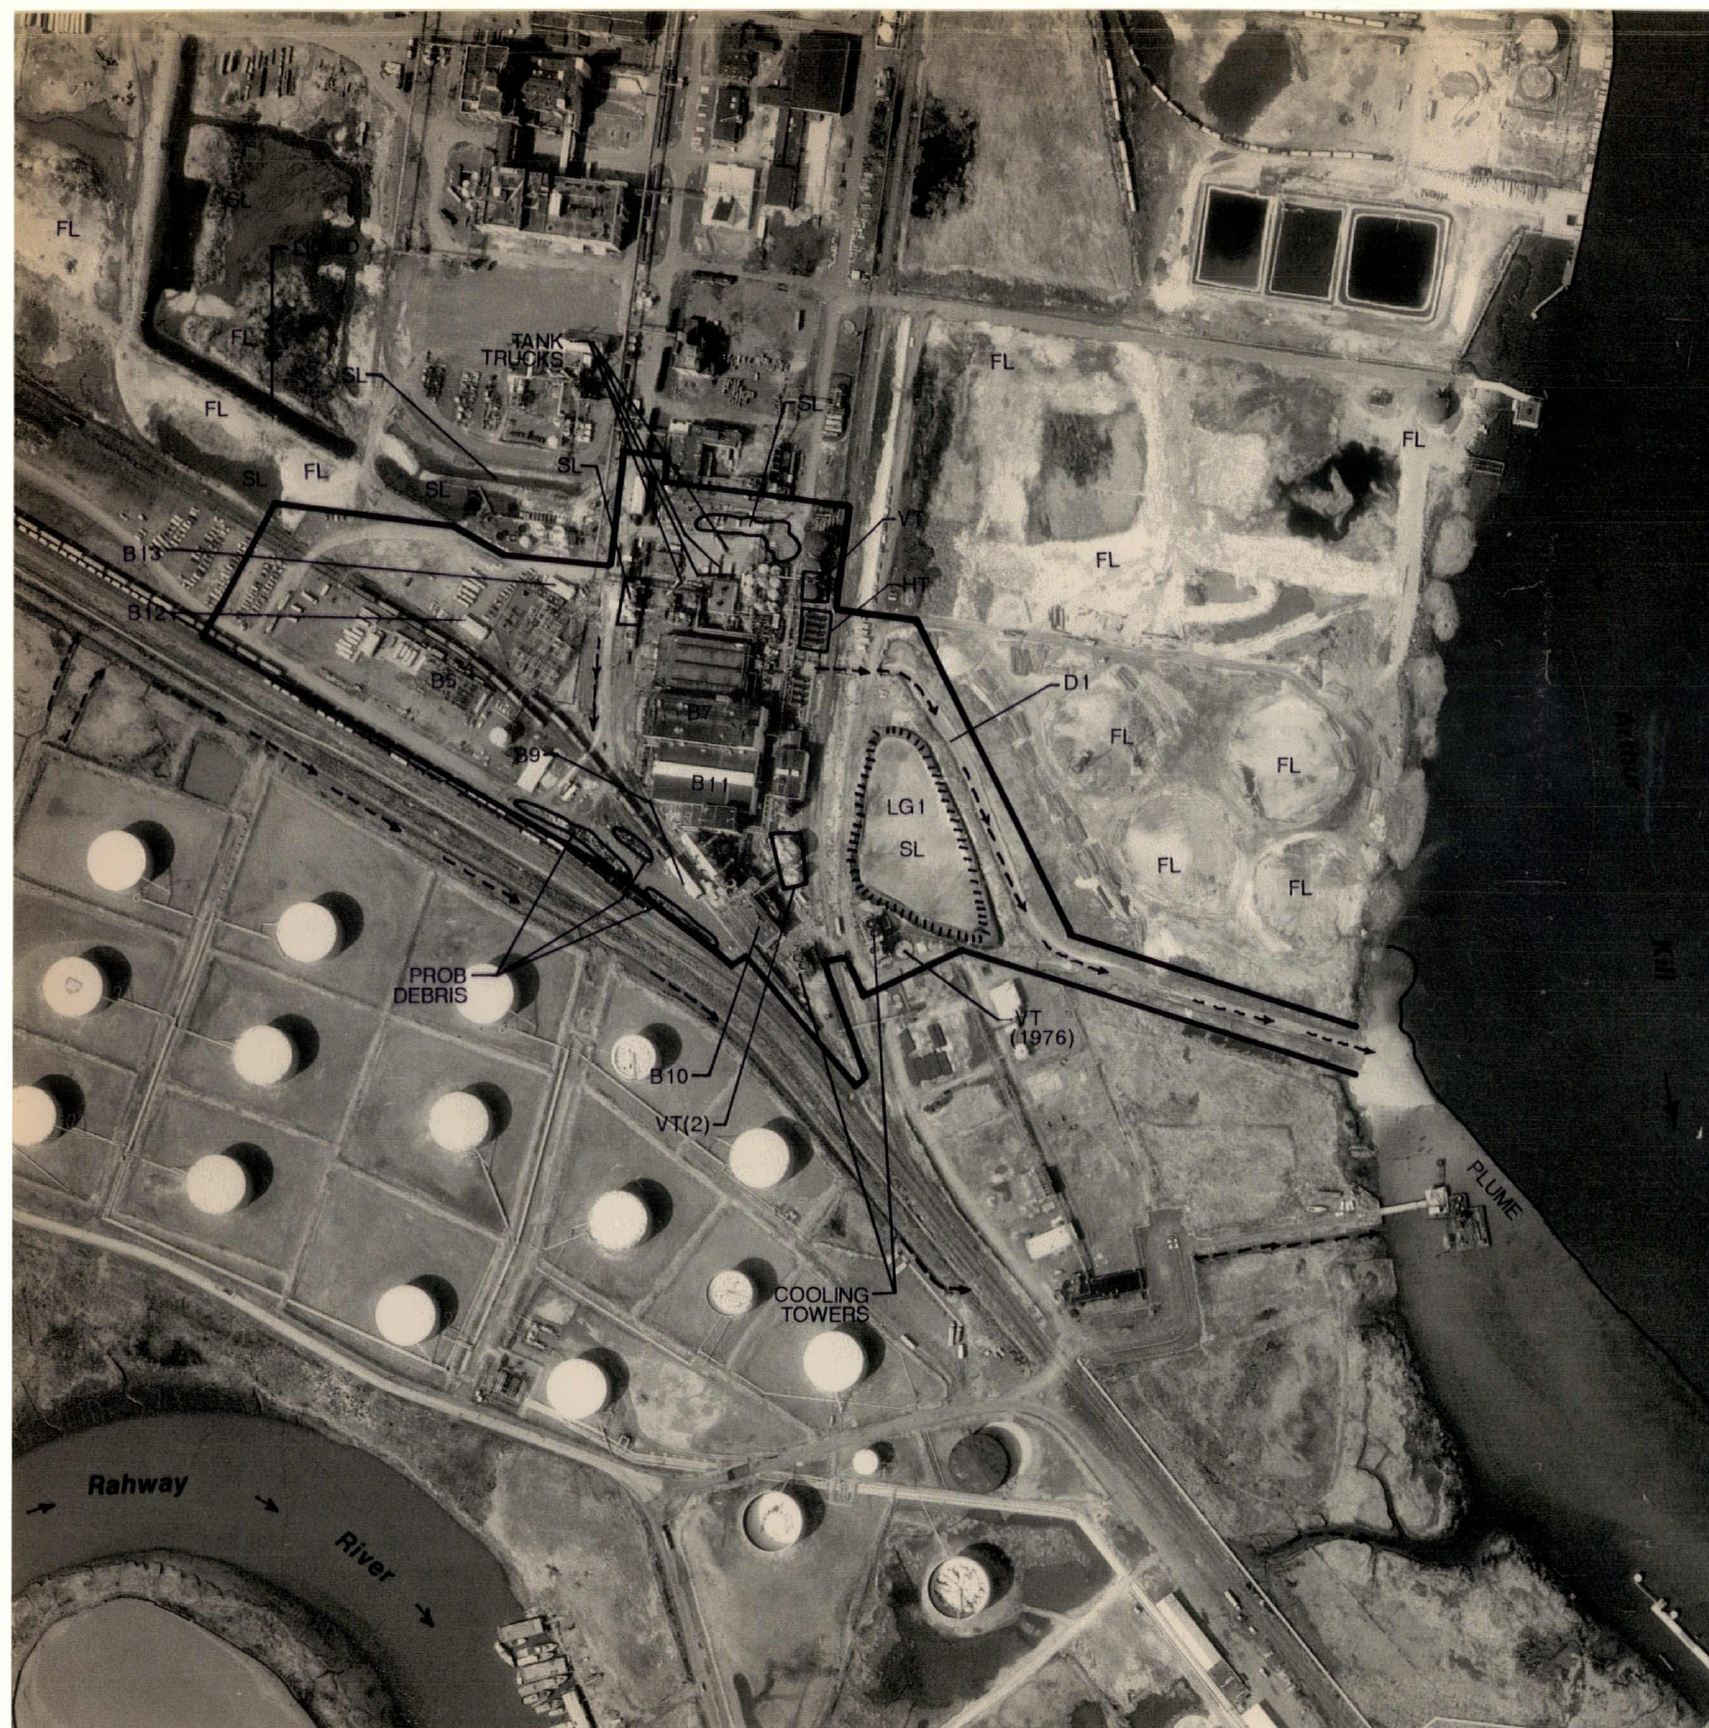
Figure 8. LCP Chemicals, Inc., site, April 11, 1974. Approximate scale 1:4,500.

APRIL 11, 1974 (FIGURE 8)

Since 1968 the chemical plant has undergone new construction with the addition of new buildings (B11 through B13) as well as new vertical and horizontal tanks used either for storage or for processing. Tank trucks are also observed within the facility.

The course of drainage ditch D1 has been altered since 1967. A light-toned plume is visible at the mouth of drainage ditch D1. The previously observed plumes (1951, 1958, and 1963) from drainage ditch D1 were dark-toned.

A liquid-filled lagoon (LG1/SL) has been constructed on the east side of the site. A bottom lining material could not be observed in this lagoon.

Standing liquid is visible in the northern portion of the site; a light-toned stain was observed at this approximate location in 1963. Accumulation of probable debris piles are observed along the southern perimeter of the site.

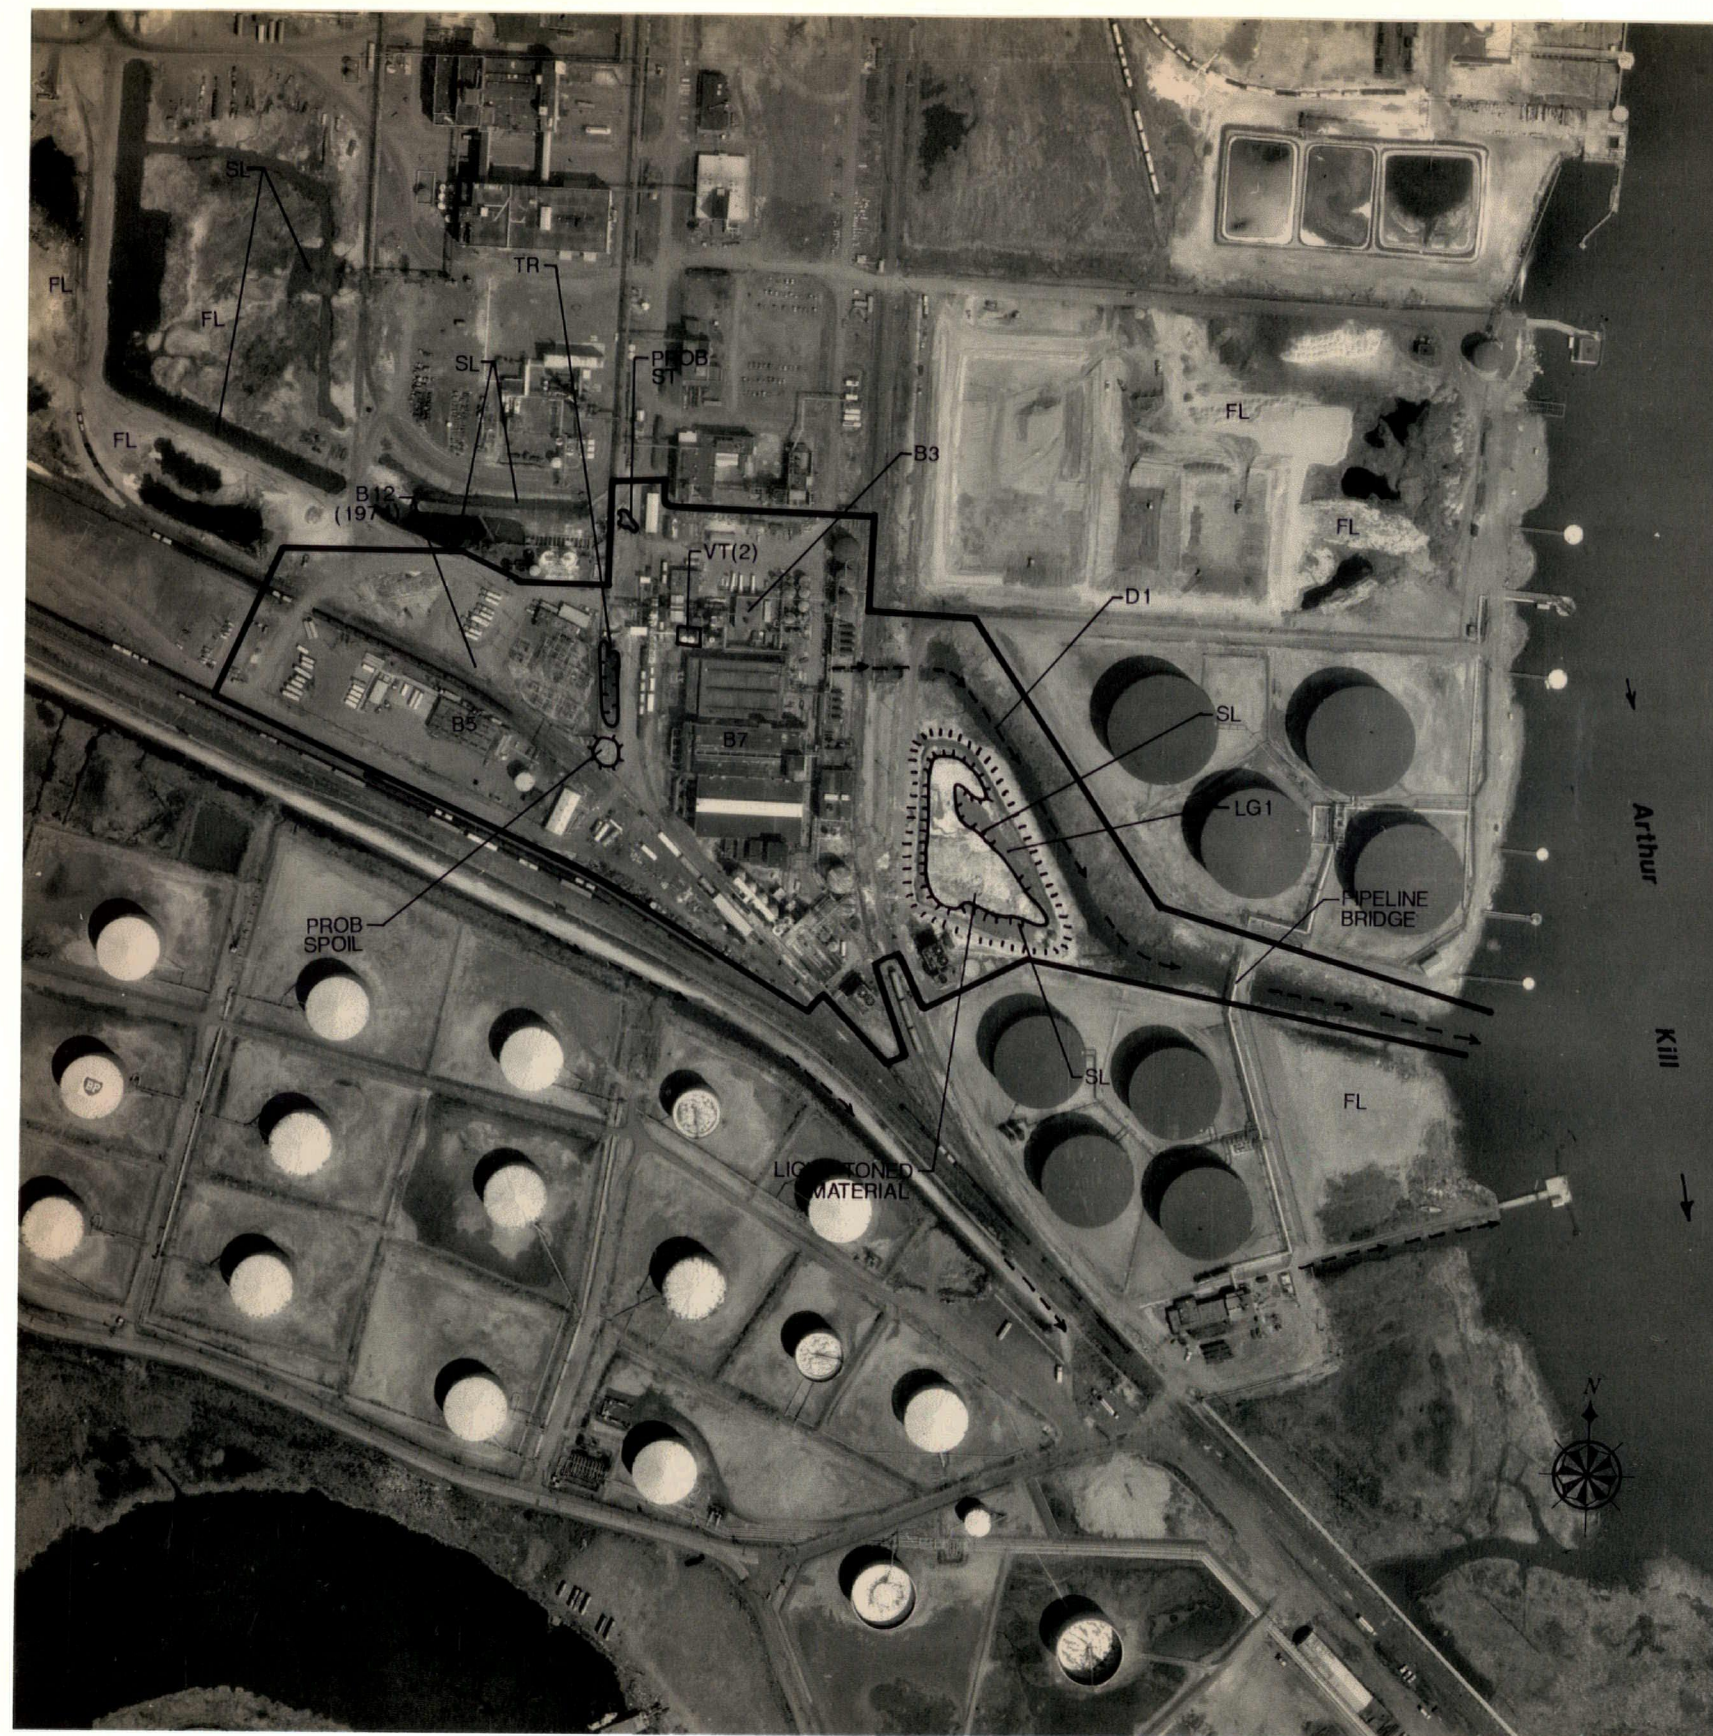
Figure 9. LCP Chemicals, Inc., site, April 17, 1976. Approximate scale 1:4,200.

APRIL 17, 1976 (FIGURE 9)

The LCP Chemicals, Inc., site continues to be operational. One ground stain is noted in the northern portion of the site. The probable debris noted in 1974 is absent.

A large excavated trench (TR) is on the west side of the railroad tank car loading racks area. The trench occupies a portion of the course of drainage ditch D1, as observed in 1963. A deposit near the south end of this trench is probable earth spoil.

A storage tank farm has been constructed along the west bank of the Arthur Kill, outside the east side of the plant. The eastern portion of the drainage ditch D1 divides this tank farm into two portions. A pipeline bridge has been built across this ditch and poses a potential threat to the Arthur Kill from rupture or leakage.

The lagoon (LG1) on the east side of the site has received a large deposit of light-toned dry material, possibly fill. The amount of visible standing liquid in the lagoon is significantly less than the amount visible in 1974.
